Case Study - Sennen Cove Lifeboat Station

Client: Seacore Ltd
Location: Sennen Cove, Lands End

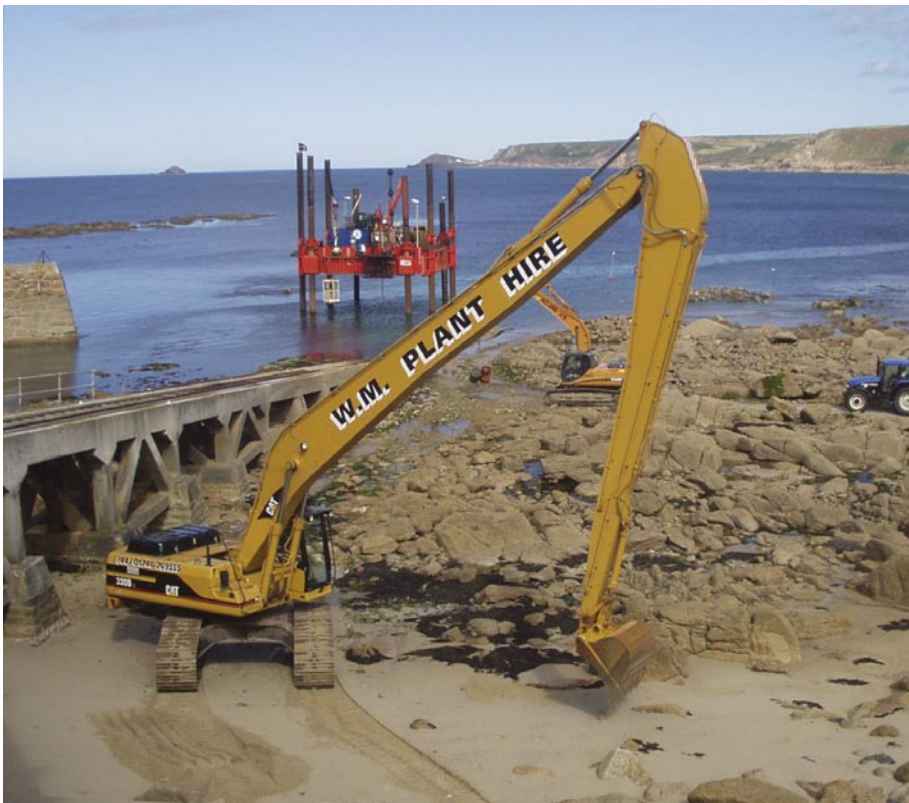
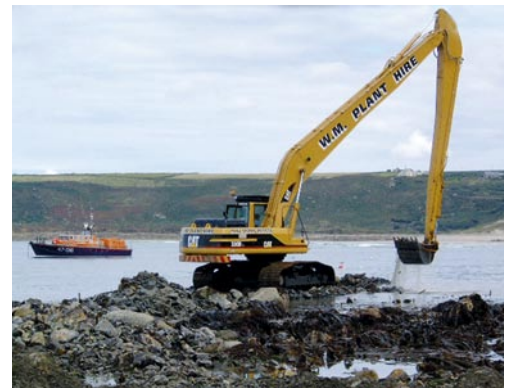
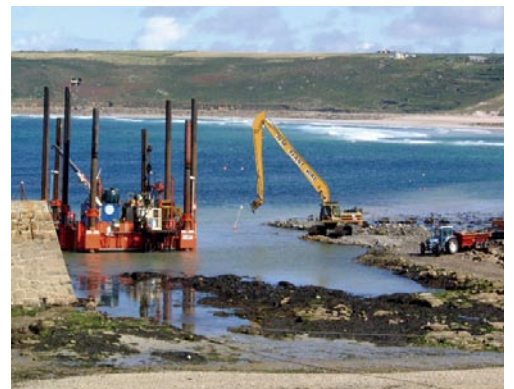
Seacore used their jack-up working platform for drilling and blasting of the rock to widen and deepen the channel. The channel was to be excavated in a series of strips, each around 10m wide by 120m long. WM Plant Hire used their 48 tonne Caterpillar 24m long reach excavator to access the site on a temporary roadway. The machine was fitted with Prolec underwater

dig profiling equipment to enable the required depth and shape to be achieved accurately. The operator can gain 'real time' information via the on board computer.
